A loose grub screw was apparently the reason why a Dutch owner of an X4⁹ in January experienced difficulties when taking part in the transatlantic race "ARC January". X-Yachts' Director of Design & Engineering, Thomas Mielec, met the boat on Gran Canaria after the boat had been salvaged.

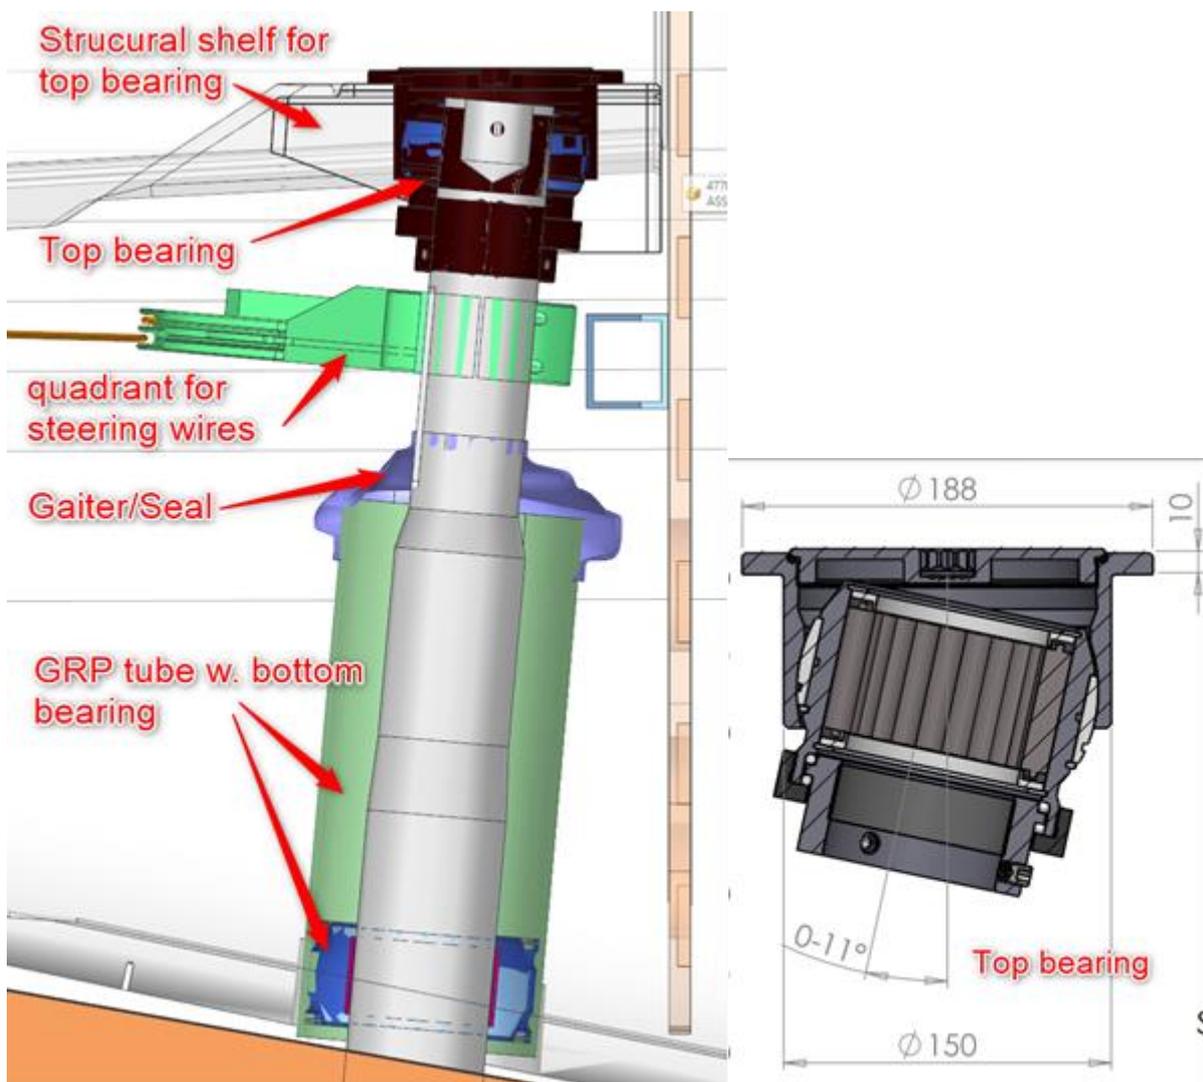
"The crew from the boat took photos and video in their attempt to repair the rudder, and it appeared that the top bearing had separated, and the rudder stock had dropped down. The rudder bearing union nut, which holds the bearing together, had simply turned off the thread at the bottom of the inner housing, and this meant that the rudder and rudder stock, which are otherwise fixed in the bearing, had dropped downwards and out of the bearing."

"This happened even though the locking screw was in place in the union nut, and that with only one impression mark, i.e. without traces or burrs, which could indicate that the union nut had been turned off with the locking screw engaged. The other parts of the bearing showed no signs of overload prior to the incident in general."

1. If it is established that there is no trace of Loctite on the locking screw, one possible scenario is, that in error, the locking screw was never secured with Loctite during manufacture of the bearing, and that the screw, without being noticed, had loosened over a period of two years, permitting the nut to also unscrew over time.

2. If tests show that there were traces of Loctite in an expected amount on the locking screw, the cause could be that the safety screw had been removed / loosened by mistake during service work, which was carried out in Spain in November.

Thomas Mielec assesses scenario 2 as the seemingly most likely.
